# MALINE CREEK ASBESTOS SITE CLOSURE AND STREAMBANK STABILIZATION STUDY

ST. LOUIS, MISSOURI

March 1993

**TapanAm associates, Inc.**  
Engineers • Architects

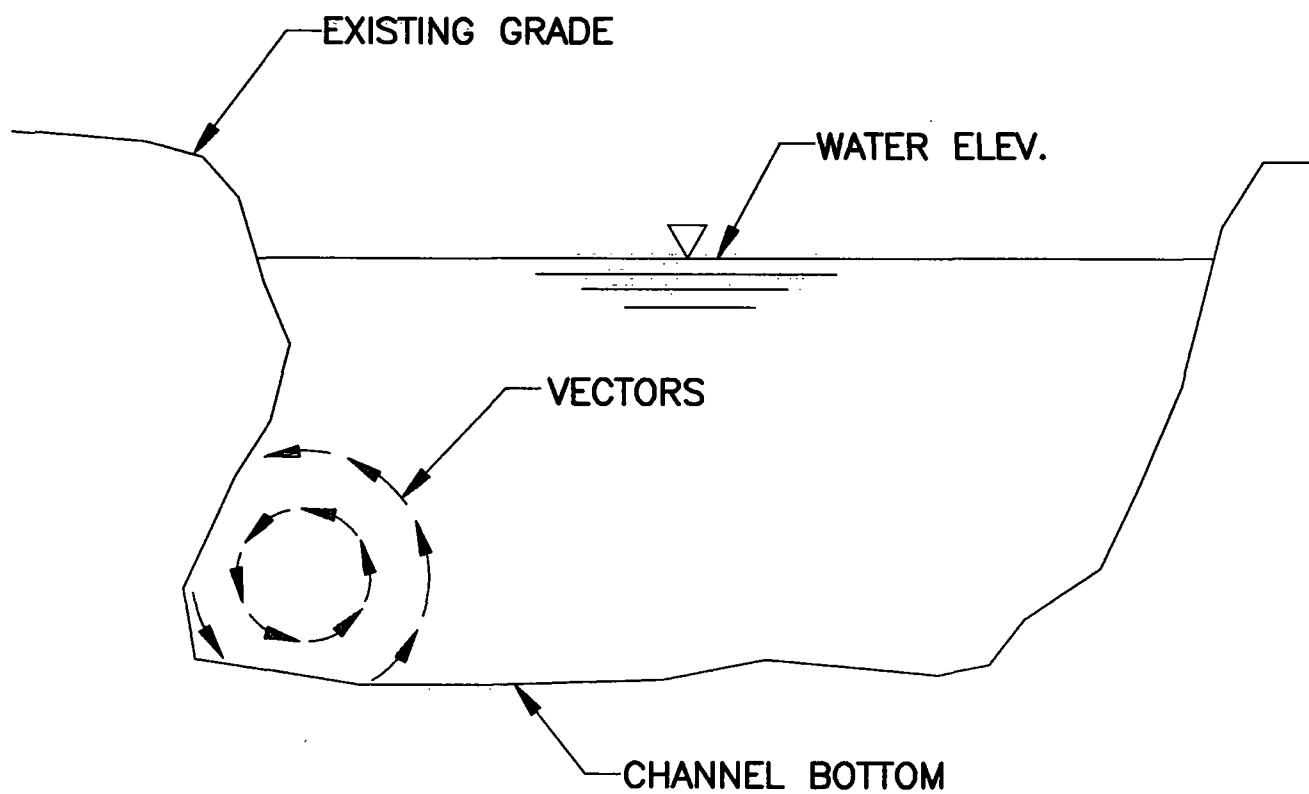
**FIGURE II-2**  
**CREEK SECTION SHOWING**  
**SPRIAL FLOW VELOCITY**  
**VECTORS**

The spiral currents generated as water moves through bends are of particular concern in the Certainteed-GAF reach. This phenomenon is peculiar to subcritical flow and accounts for much of the embankment scour which can be seen even in some relatively tranquil streams. Such currents describe a helical path in the direction of flow and introduce transverse velocity components to the channel section (Figure II). These currents are believed to be caused by filamental velocity differences between the center of the channel and the channel wall induced by friction; centrifugal force which deflects water particles from straight line motion; and a vertical velocity distribution in the approach channel which initiates the spiral motion. Looking downstream, a bend to the right induces counterclockwise motion, while a bend to the left induces clockwise motion. Such currents are probably the primary reason for the severe undermining process seen at and below the Riverview Branch tributary bend. Spiral currents tend to persist for some distance downstream when a curve is followed by a long straight tangent and, therefore, their impact is not merely local. The extensive damage done along the Certainteed-GAF northeast bank well below the bend is a prime example of their effect.

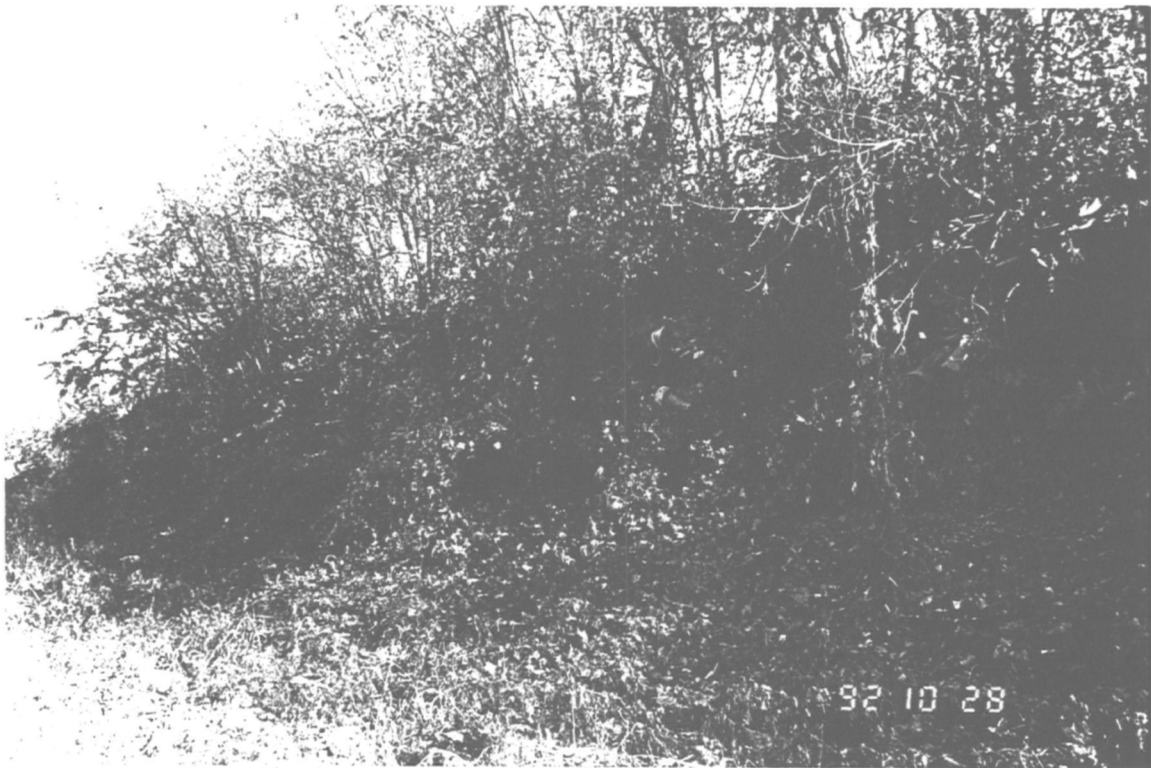
Figure III - 1      Looking North at approximately 1/2 mile  
SE of Riverview Branch tributary.

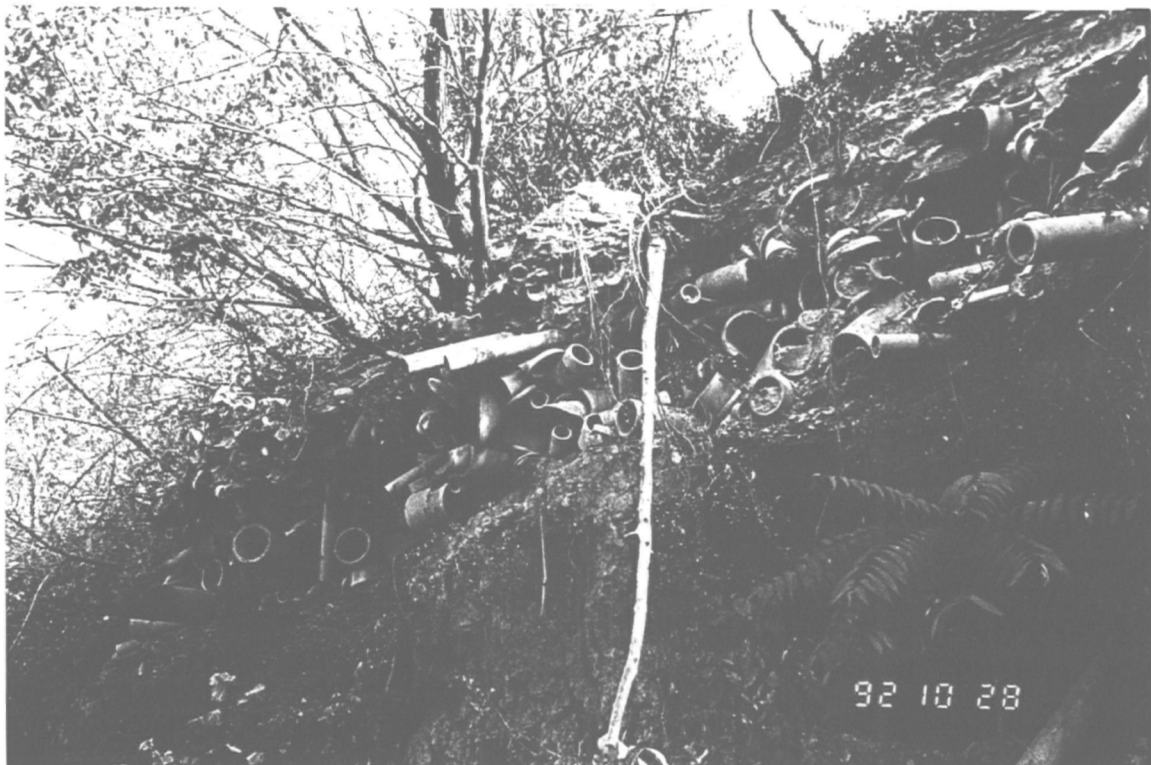
The majority of the asbestos pile in the creek bed is caused by collapse of asbestos material from the bank into the creek bed where water has undermined the soil beneath the stratum (Figure III-3 and III-4). Water has subsequently carried some of this debris downstream, scattering pieces of cement asbestos pipes along the entire length of the creek.

Figure III - 2      Close-up of NE bank from Riverview Branch  
tributary, approximately 1/2 mile  
tributary to show stratum of asbestos  
materials

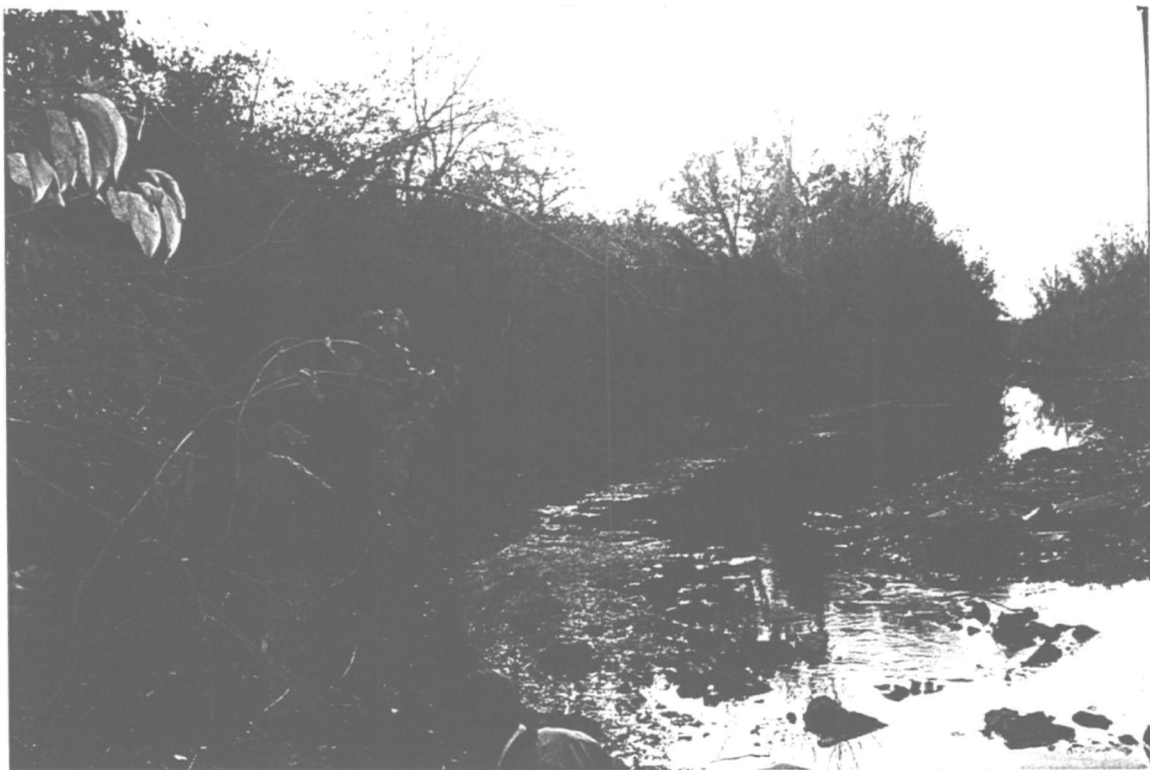
Figure III - 3      Looking SE from Riverview Branch tributary to show asbestos material on creek bed.

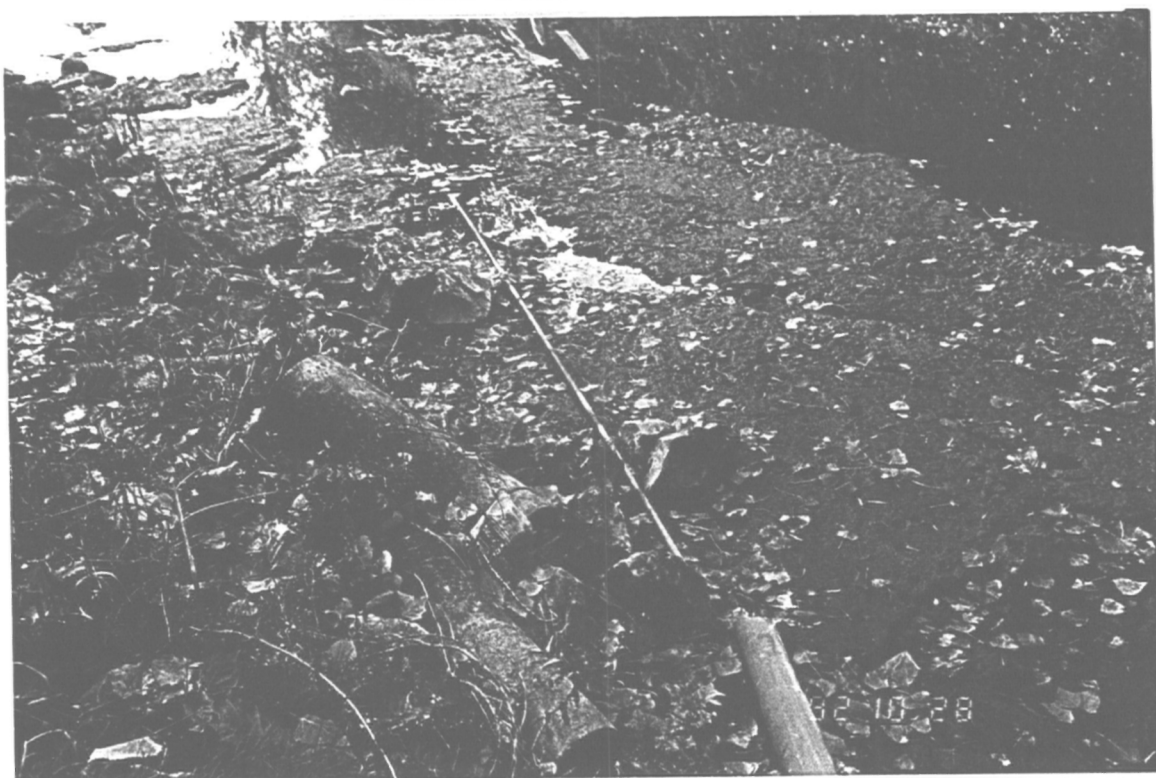
Figure III - 4      Close-up to show asbestos material scattered on creek bed, looking south at Maline Creek from Riverview Branch tributary.

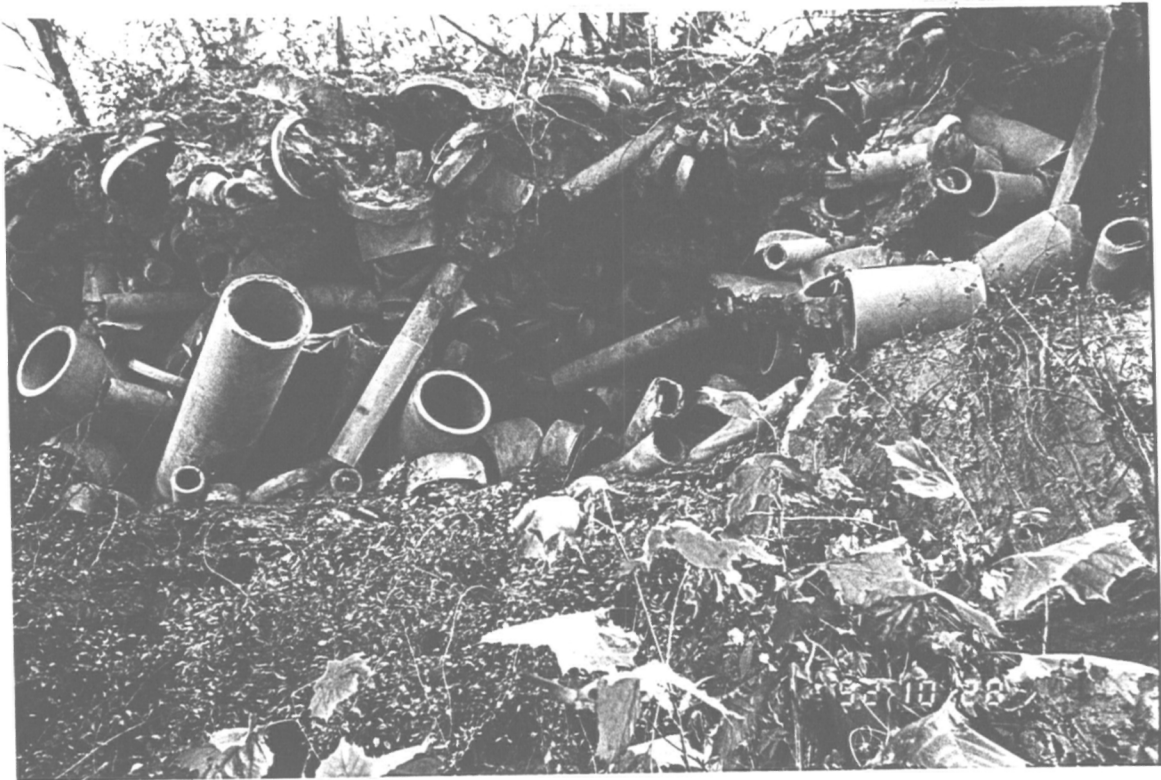
Figure III - 6

The materials in the creek bed showed signs of advanced deterioration probably due to water erosion and freeze thaw actions. Other factors noted as contributing to the breakdown of the non friable materials include stress induced by plant roots and vehicles running over the materials scattered in the parking area.

Transite pipe, connectors and pipe collars along NE bank from Riverview Branch tributary.

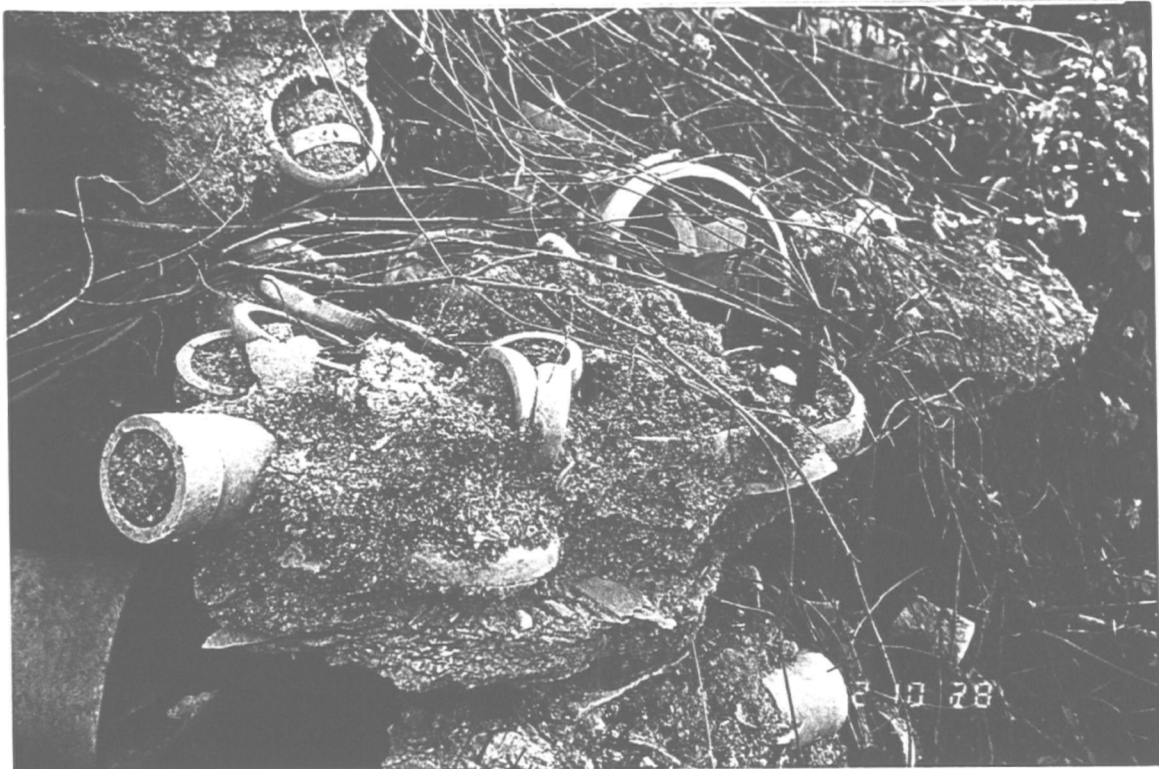
Figure III - 7

Friable materials identified at the site include pipe insulation, impregnated cloth and solidified cement slurry. Weathering and deterioration of non friable materials may lead to delamination, where the material begins to split and pull apart thus releasing fibers.

Close-up of asbestos pipe in solidified slurry.

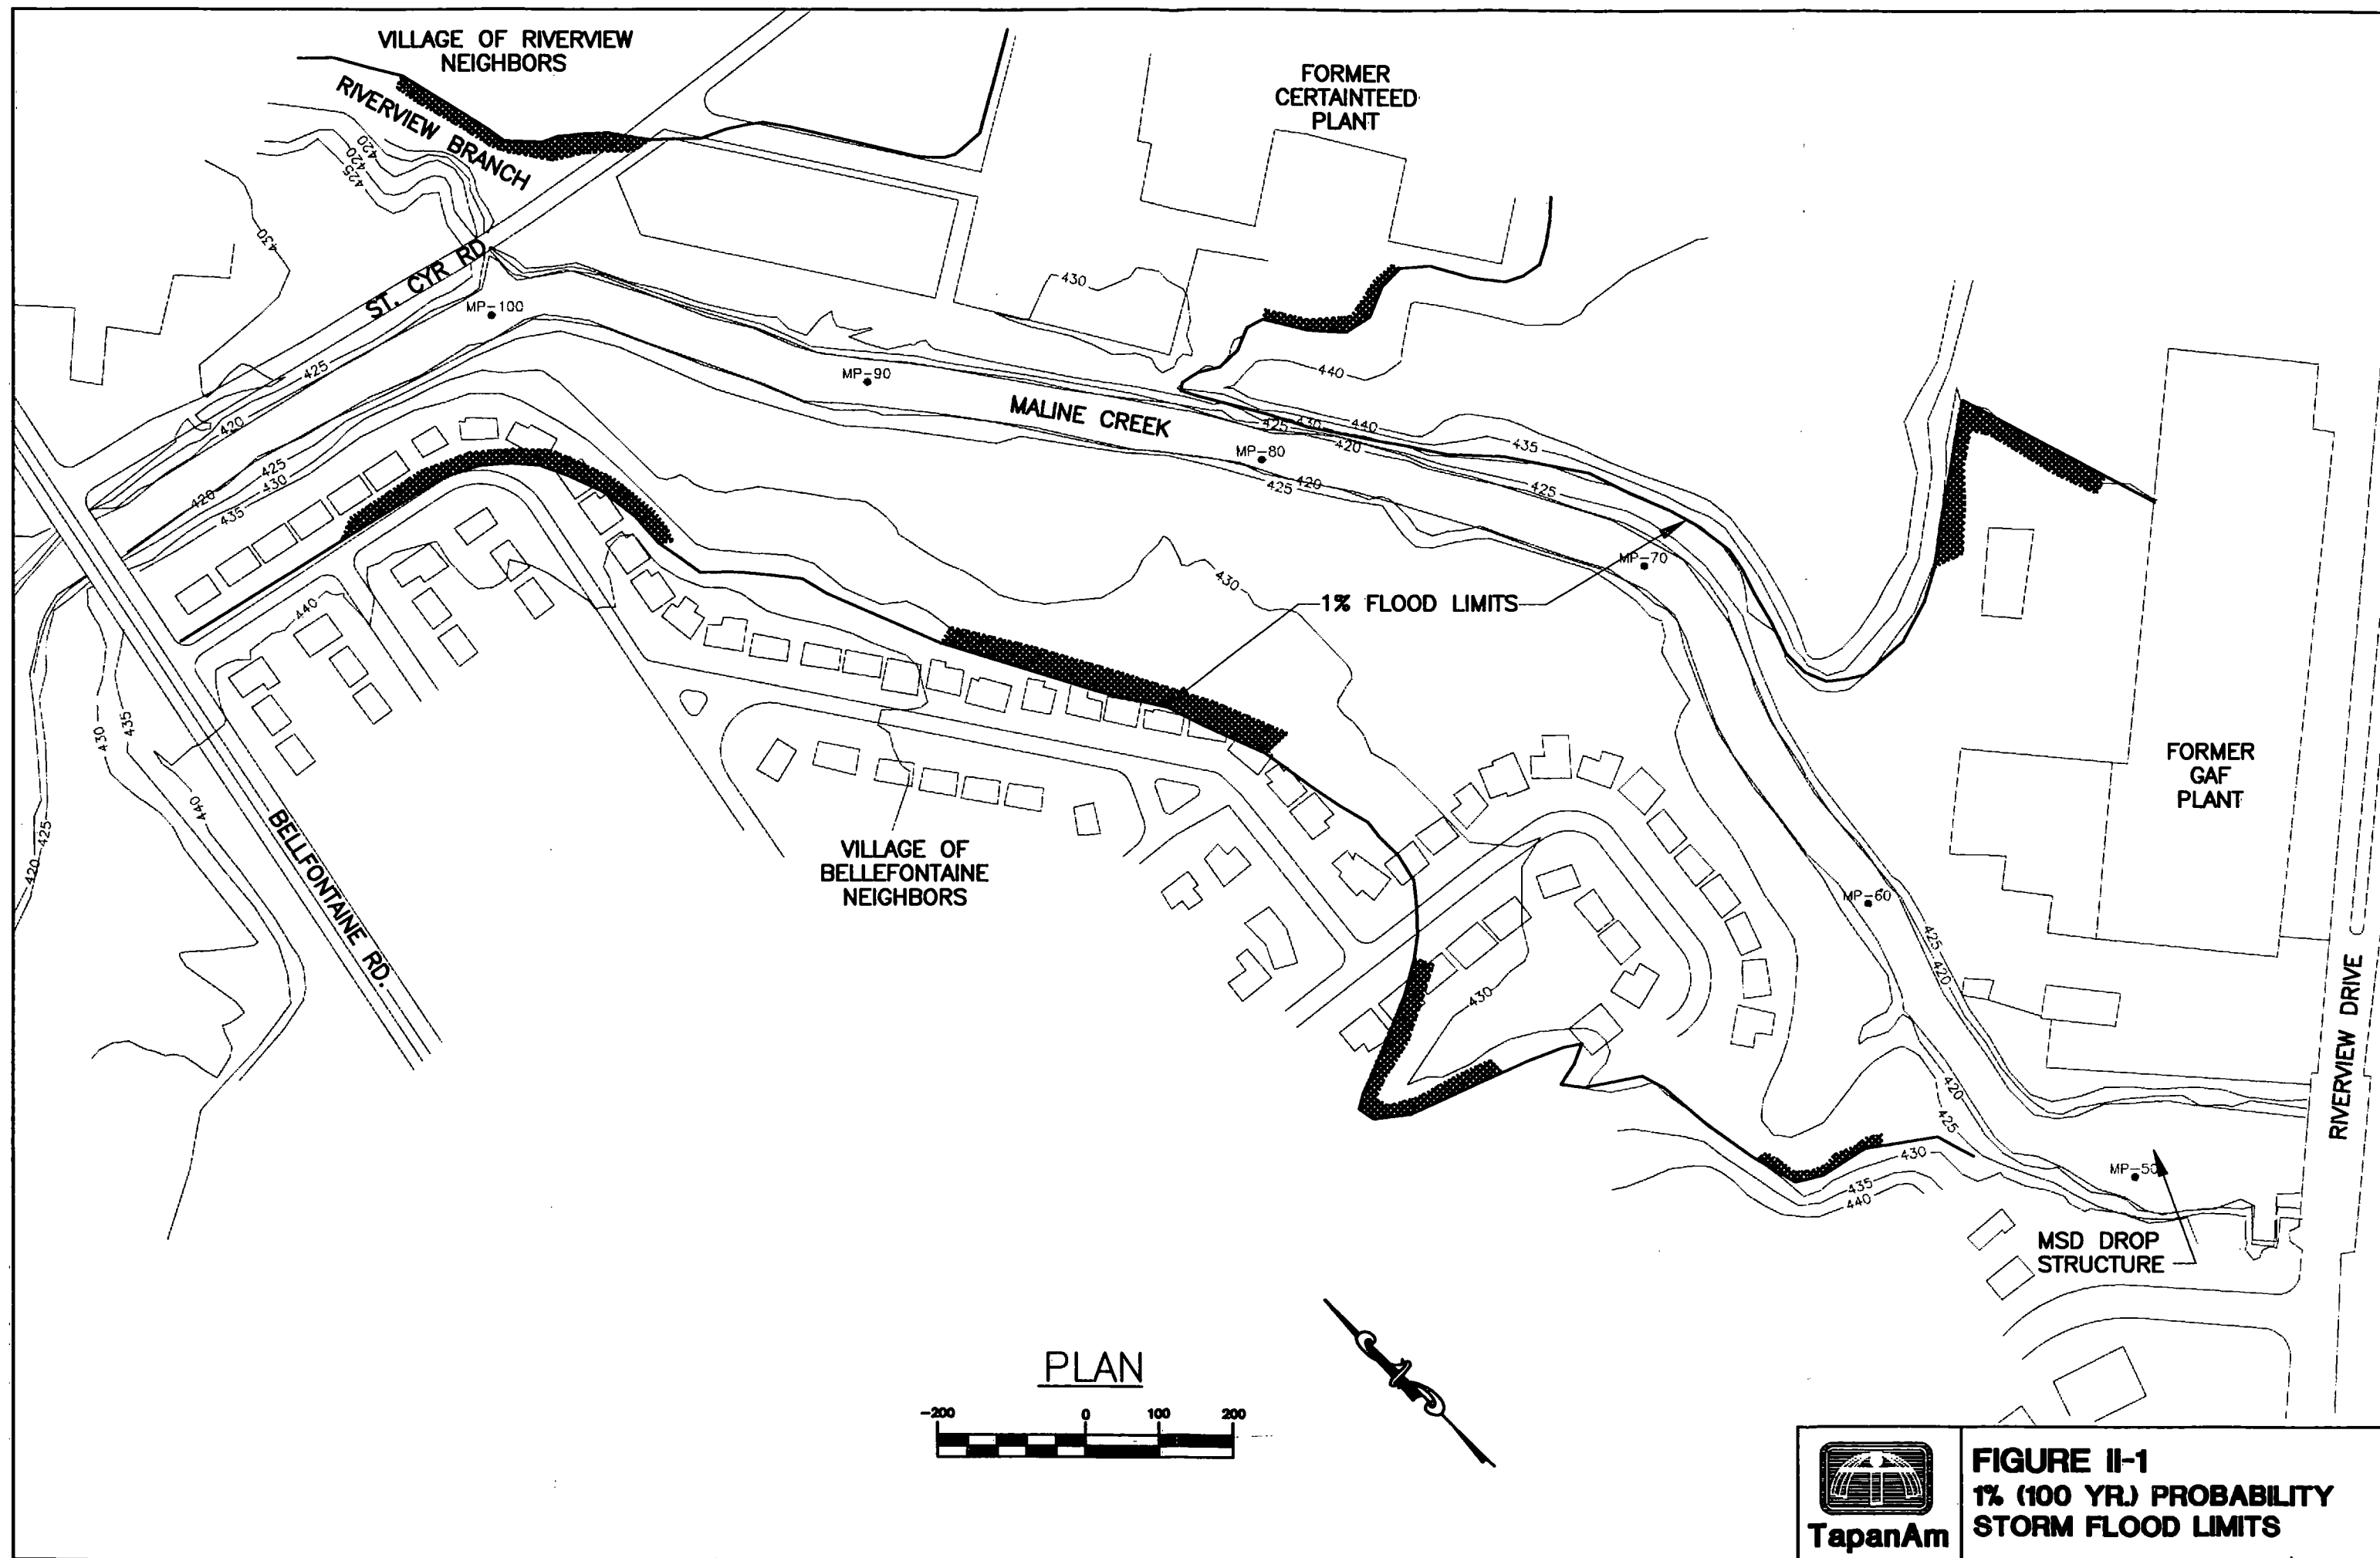
**FIGURE II-1**  
**1% (100 YR.) PROBABILITY**  
**STORM FLOOD LIMITS**

The Metropolitan Sewer District Drop Structure at Station 0.527 miles is the point of control for water surface profiles along the Maline Creek reach adjoining the Certainteed-GAF asbestos fill sites. Throughout the reach, flow is severely restricted as a result of low conveyance due to mild channel slopes (<0.2%); inadequate cross sectional area; irregular (non prismatic) sections and transitions; and the presence of natural and man placed roughness elements such as brush, trees, rocks, failed riprap, construction debris, asbestos cement pipe, buildings, etc. Discharge is, therefore, in the subcritical flow regime and results in flooding conditions for storms of 10% probability (10 year) or greater. Extensive flooding is seen during the 1% (100 year) event when most of the Certainteed-GAF site and much of Bellefontaine Neighbors west of the creek are inundated (Figure II-1).

One of those forces is the frequent flood cycle extant in the area. Even the 10% (10 year) storm causes minor flooding, while the 1% (100 year) event inundates homes in Bellefontaine Neighbors and the former asbestos factories. This is apparent from both
